# INDUSTRY UPDATE

Polymeric Cladding and Wind Performance 2020

Data, Observations and  
Recommendations Moving Forward

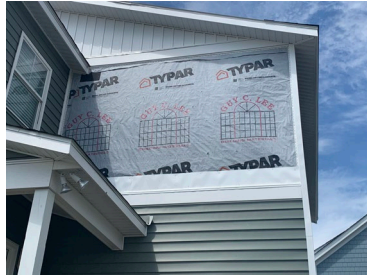
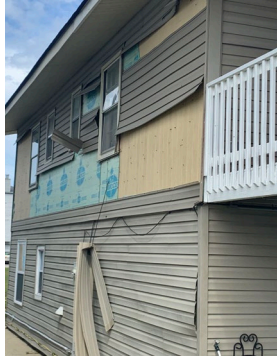
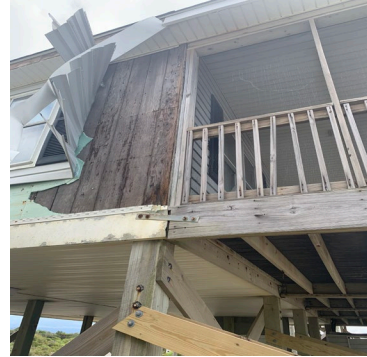
General observation: Properly specified product installed correctly performs in high-wind regions.

Observations when failure occurred:

- Most noted failures were fascia related
- Soffit failures were noted and were more vulnerable when used in large porch ceiling applications and as a ceiling application under homes (homes are built using piles)
- Siding failures occurred more in residing applications than new construction
- Fastener corrosion contributed factor to siding failure in a number of cases
- Gable ends have more noticeable failures
- Instances of using J-channel without utility trim/punch locks or as starter strip were noted
- Still noticeable nonhigh-wind single nail hem products used

- Highlight need for use corrosion resistant fasteners
- Consider broadening soffit instruction to include more specifics on porch ceiling installation and bottom of home ceiling application, new code changes address this issue
- Consider highlighting fasteners that can be used without hitting stud (e.g. ring shank or screws)
- Study and provide stronger direction on fascia installation
- Continue focus on coastal applications and education of installers, builders, code officials

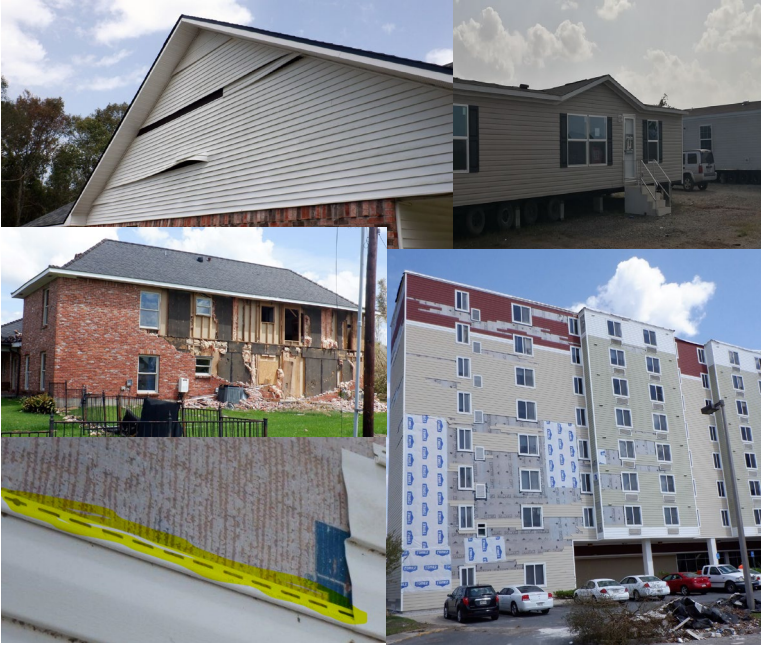
## Improper Installation

- Siding failures are the result of improper nailing patterns, often wider than 16-inches on center
- Instances of improper use of J-channel were noted
- Lack of solid sheathing, especially at gable ends and chimneys, may have contributed to siding blow off, as without solid sheathing (and at gable ends, also drywall) the siding becomes subject to more severe wind pressure without equalization
- Soffit failures were noted, most in combination with fascia failure, code changes correct this issue
- Non-high wind related product, improper specification
- All materials impacted in Lake Charles region, note multifamily construction and brick construction with major damage

- Education On Proper Installation / Inspections
  - Installers, Building Officials, Architects, Designers
- Focus on siding installation performance at gable ends, chimneys and other locations without interior drywall
- Highlight fasteners that can be used without hitting stud, for example as allowed ring shank nails
- Study fascia installation
