# INDUSTRY UPDATE

Polymeric Cladding and Wind Performance 2020

Data, Observations and  
Recommendations Moving Forward

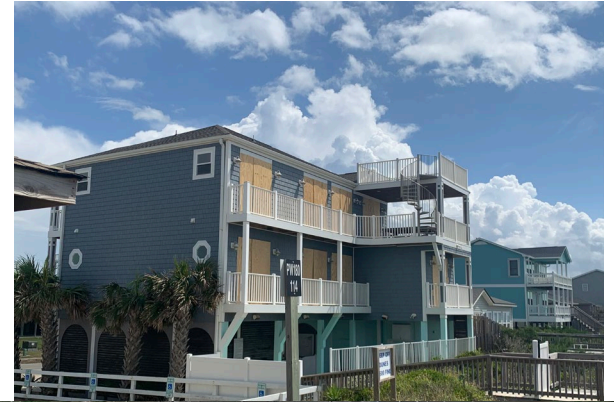
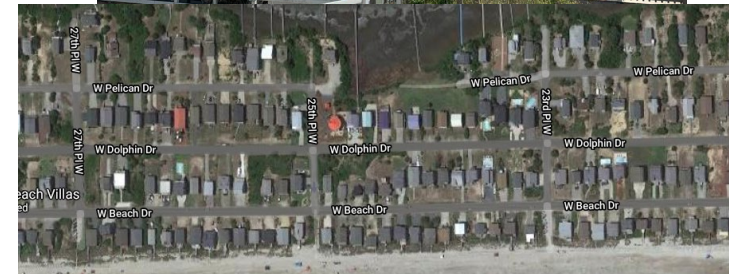
- Damage was both storm surge (water), wind and fire.
- Note only catastrophic / complete damage was fire related

- 40 (<10%) Oak Island
- 10 (<10%) Holden Beach
- Major damage (non-catastrophic) was storm surge related

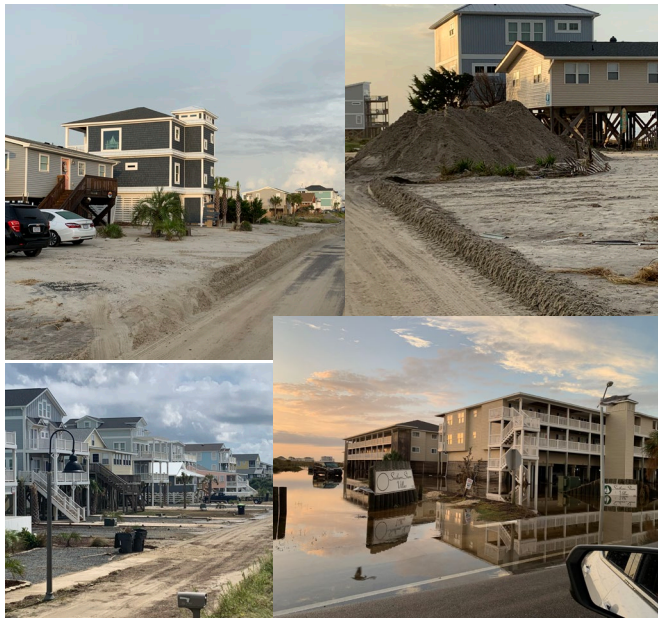
- Most noted failures were fascia related
- Soffit failures were noted and were more vulnerable when used in large porch ceiling applications and as a ceiling application under homes (homes are built using piles)
- Siding failures occurred more in residing applications than new construction
- Fastener corrosion contributed factor to siding failure in a number of cases
- Gable ends have more noticeable failures
- Instances of using J-channel without utility trim/punch locks or as starter strip were noted
- Still noticeable nonhigh-wind single nail hem products used

- Highlight need for use corrosion resistant fasteners
- Consider broadening soffit instruction to include more specifics on porch ceiling installation and bottom of home ceiling application, new code changes address this issue
- Consider highlighting fasteners that can be used without hitting stud (e.g. ring shank or screws)
- Study and provide stronger direction on fascia installation
- Continue focus on coastal applications and education of installers, builders, code officials

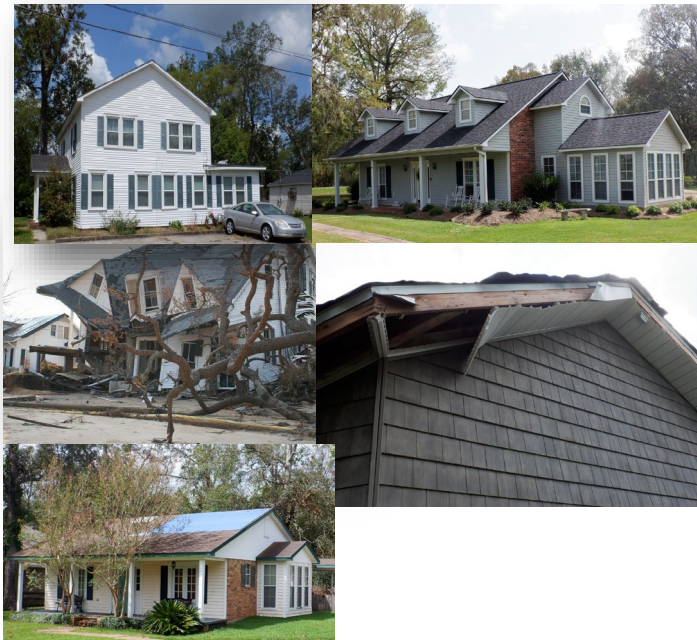
- Approximately 30%-40% of homes used polymeric cladding, 80% of which minor to moderate damage.
- All construction types and cladding types were damaged.
- Some catastrophic damage, more related to falling trees than direct wind issues.

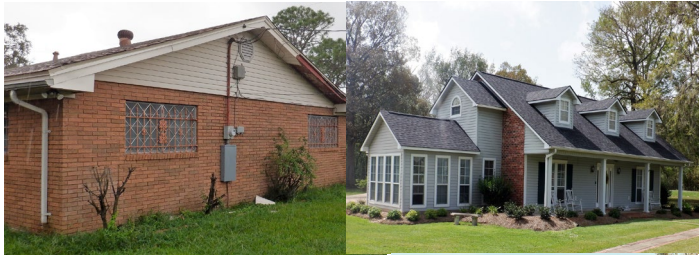
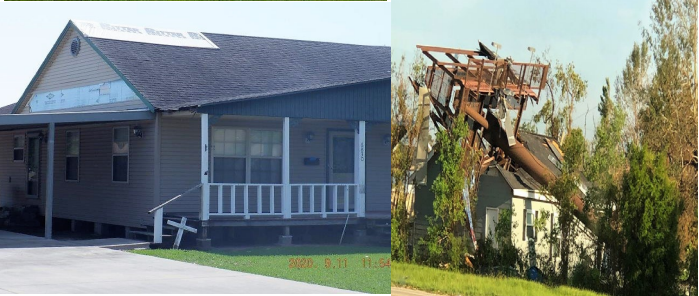
- Siding failures are the result of improper nailing patterns, often wider than 16-inches on center
- Instances of improper use of J-channel were noted
- Lack of solid sheathing, especially at gable ends and chimneys, may have contributed to siding blow off, as without solid sheathing (and at gable ends, also drywall) the siding becomes subject to more severe wind pressure without equalization
- Soffit failures were noted, most in combination with fascia failure, code changes correct this issue
- Non-high wind related product, improper specification
- All materials impacted in Lake Charles region, note multifamily construction and brick construction with major damage

- Education On Proper Installation / Inspections
  - Installers, Building Officials, Architects, Designers
- Focus on siding installation performance at gable ends, chimneys and other locations without interior drywall
- Highlight fasteners that can be used without hitting stud, for example as allowed ring shank nails
- Study fascia installation

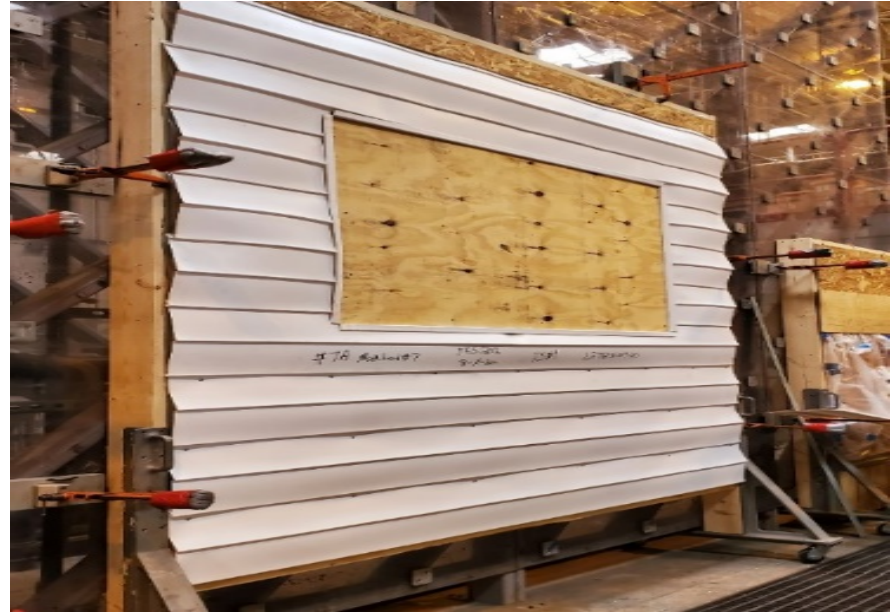
- “Economy panels” (non-coastal) are not as susceptible to nail withdrawal under normal wind conditions and therefore improper installation, meaning nails hitting studs, will be less problematic
- “Premium panels” (coastal) must be installed properly. Improper installation will result in fastener failures in high wind events. Alternative installation should focus on stronger fasteners as fastener withdrawal is the noted means of failure in high wind scenarios utilizing alternative fastener spacing
- J-channel cannot be used as a starter strip as doing so greatly reduces the wind performance of the system
- Current punch lock specifications are adequate for performance in coastal settings
